## J/111 Steering System Inspection Reminder

To: J/111 Owners – USA Built Boats

## J/111 TECHNICAL BULLETIN

### **Re: Installing Retaining Bolt in J/111 Upper Rudder Post Sleeve.**

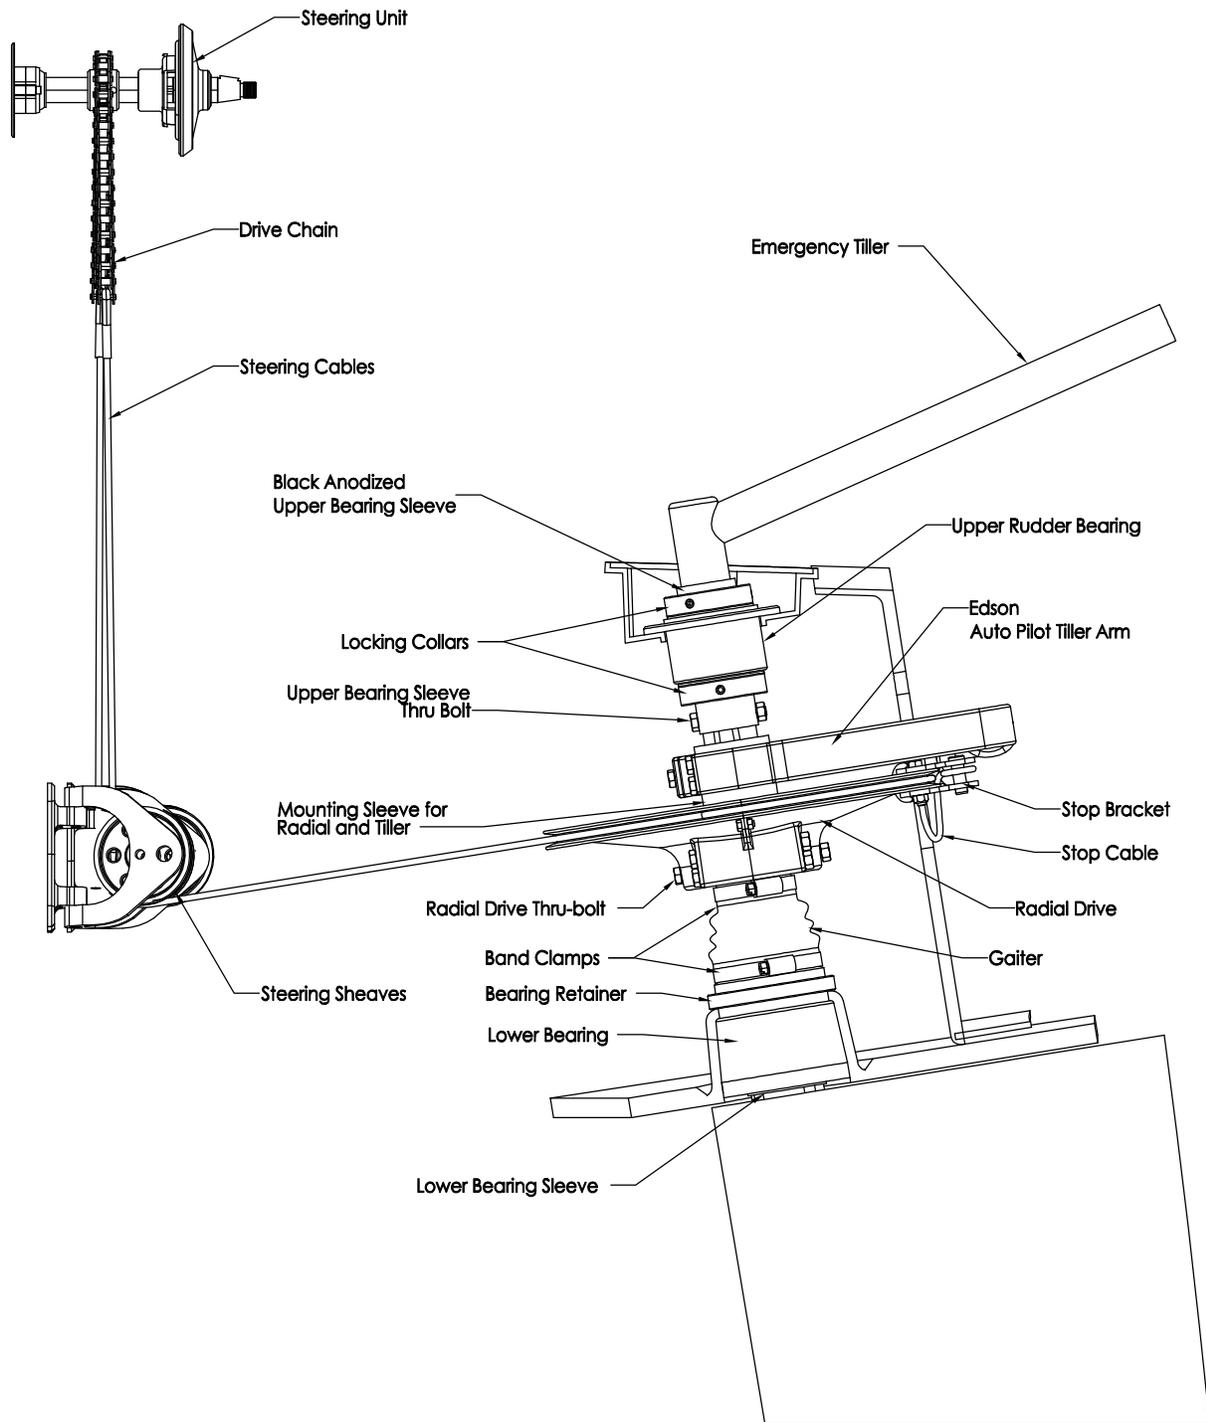
# J/111 US Steering System Hardware

A general diagram of the J/111 system was provided with the J/111 Owner Manual. We have included a more detailed version of this drawing here and a complete Best Practices – Wheel Steering Systems article to help you understand key components and to remind you how to maintain and inspect wheel steering systems. In addition you may source this helpful information online at [www.jowners.org](http://www.jowners.org).

2. **Top of rudder clearance with hull** - The clearance between the top of the rudder blade and the bottom of the hull should be NO LESS than 4mm. This clearance is engineered to be maintained by the locking collar mounted immediately below the upper rudder bearing on the rudder post at the black aluminum top cap. This clearance should be inspected regularly and prior to offshore passages. Any visual signs of chafe at the hull or bottom paint is cause for concern. Lock collar condition and status of this gap should be checked and adjusted accordingly. Locking collars are located on the rudder post as shown in the diagram and need to be checked regularly for condition.

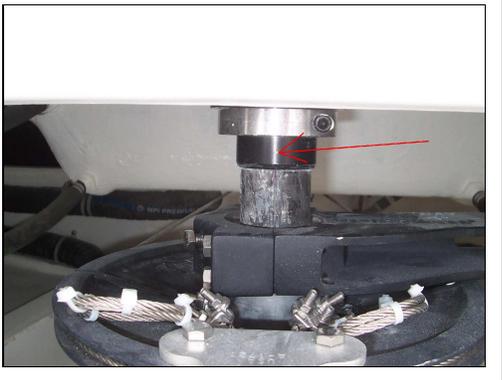
<b>Mark for the Bolt</b>	<p>Center the rudder and lock the wheel in place.</p> <p>Looking through the aft cockpit hatch, mark the black aluminum sleeve on the rudder post about half-way down from the collar on centerline.</p>

A close-up photograph of the rudder post assembly. A black aluminum sleeve is mounted on a carbon fiber rudder post. A red arrow points to the sleeve. The assembly is surrounded by steering cables and other mechanical components.
--------------------------	--	--

A steering problem in the Marblehead-Halifax race has drawn our attention to a potential issue that could develop with the top sleeve on the rudder post. A Jefa, hard-coated, black aluminum sleeve is epoxied to the top of the carbon rudder post, and is held in place in the boat by the upper rudder bearing and a lock collar. On the boat in question, the aluminum sleeve worked loose of the rudder post (epoxy bond issue), and the rudder slid down a few inches, loosening the steering cables and causing the chain to jump the sprocket. The quadrant kept the rudder from dropping any lower and the gaiter kept the water out.

After researching the issue, CCF/J Boats have developed a simple fix to be sure this cannot happen. A bolt is installed through the upper aluminum sleeve and the rudder post as a positive means of retaining the post in the sleeve. This will be a standard feature on new J/111's in production, and we recommend installing the bolt on boats in the field. One labor hour is allotted for the procedure, as outlined below. Please contact CCF or J Boats with any questions.

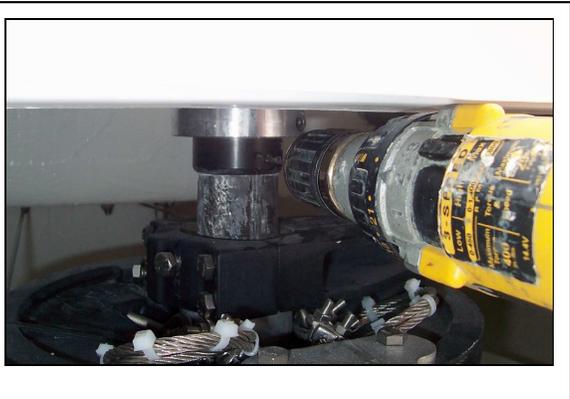
<p><b>Drill for the Bolt</b></p>	<p>Drill a 1/8" pilot hole to be sure the alignment is correct through the sleeve and the post.</p> <p>Follow with a 1/4" hole for the bolt.</p> <p>Depending on the size/shape of your drill, it may be helpful to use a long 1/4" drill bit.</p>

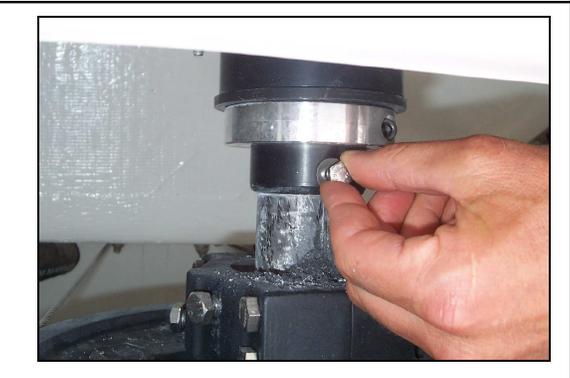
<p><b>Dry fit the bolt</b></p>	<p>Be sure the bolt will go through cleanly.</p>

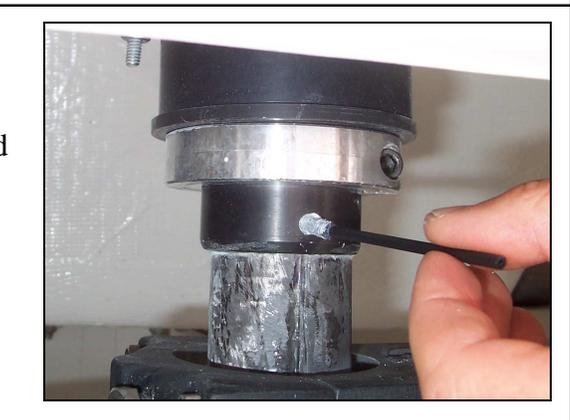
<p><b>Apply Tef-Gel or Duralac</b></p>	<p>Since we're putting a stainless bolt through aluminum and carbon fiber, we suggest using Tef-Gel or Duralac on the exposed aluminum at either end of the hole to prevent corrosion.</p>

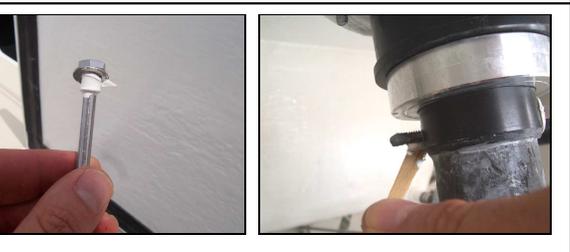
<p><b>Install the bolt with sealant</b></p>	<p>A little sealant on the bolt at either end is also a good idea. Then tighten the bolt/nut with wrenches or a socket. Do not overtighten – just snug is fine.</p>

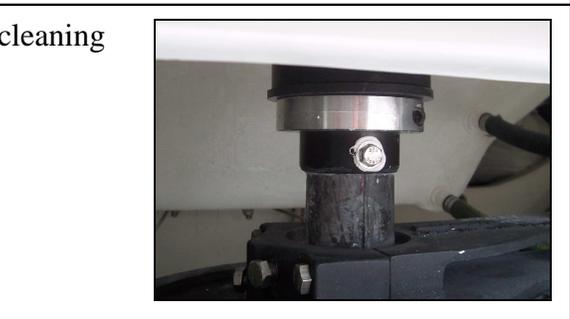
<p><b>Finish and Clean</b></p>	<p>A portable vacuum is a great help for cleaning the area.</p>
